**A RESOLUTION RECEIVING AN UPDATE ON PEDESTRIAN SAFETY ON  
NORTH GREENSBORO STREET  
Resolution No. 159/2009-10**

**RE:** Update on Pedestrian Safety on North Greensboro Street

**The use of Rectangular Rapid Flashing amber Beacons, (*RRFB*)  
as a potential for increasing motorist yielding compliance  
at select mid-block crosswalks in Carrboro**

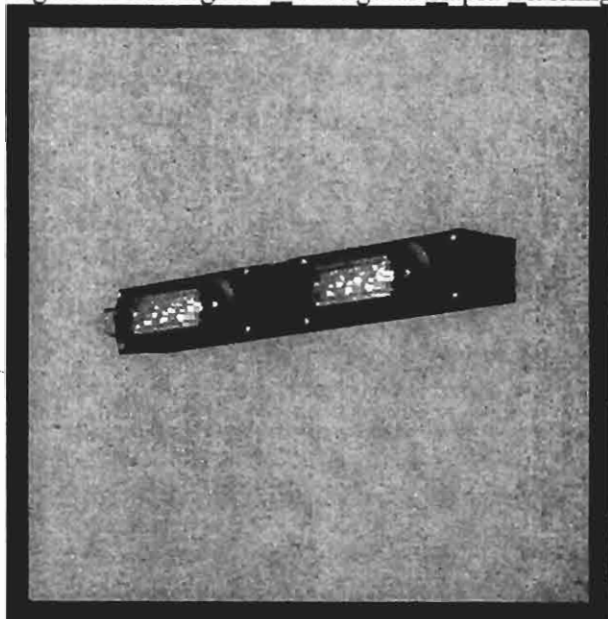
Figure 1 Rectangular Rectangular Rapid Flashing amber Beacons

The LED flashers beacons of the Rectangular-shaped Rapid Flash used in the study were six (6) inches wide, 2.5 inches high, and placed nine (9) inches apart. Each unit was dual indicated (LED's on front and back). These beacons were mounted under mounted under pedestrian crosswalks signage (Figure 2.) Each side of the LED beacon flashed a yellow light in a wig-wag flashing sequence (left light on, then right) - the two LED's in combination flashed 190 times in the wig-wag flashing sequence during a 30 second cycle. The stutter flash pattern is similar to that used on emergency vehicles.

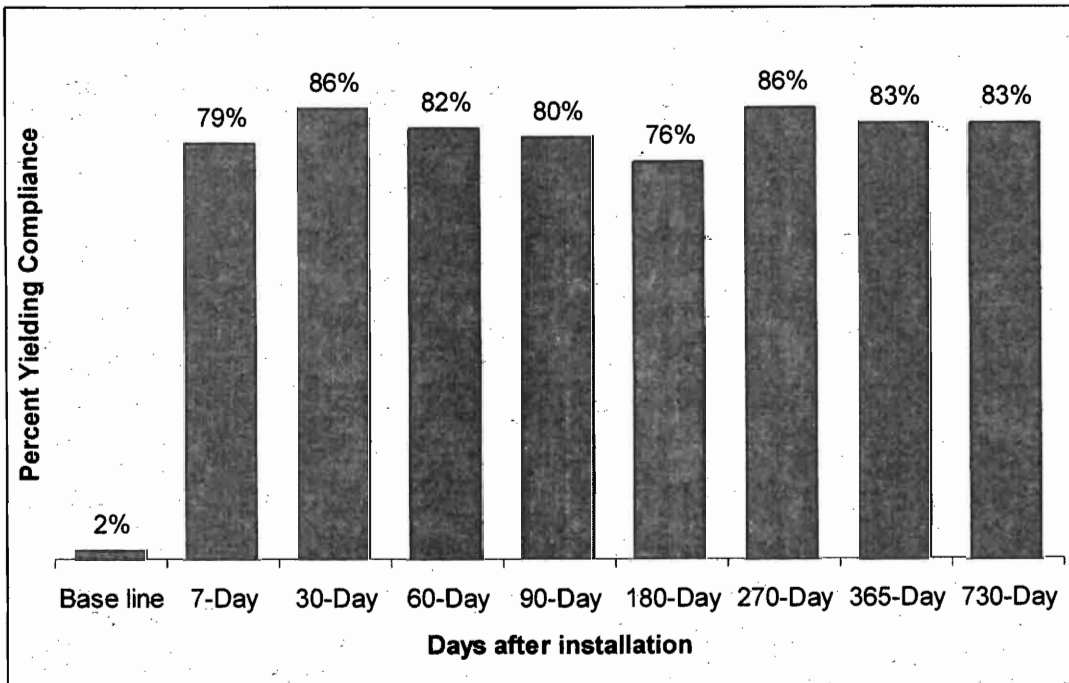
The results indicated that the RRFB devices dramatically increased yielding levels from single digits at several locations and 20% to 30% at other locations to 80% to 90% at most sites. No other device without a red indication, such as a traffic signal, has produced similar yielding data. Figure 3 illustrates the average percent of motorist yielding compliance over time for all 18 sites where the RRFB were installed. The RRFB produced sustained yielding behavior. It should be noted that because all 18 devices were not installed simultaneously not all data point represent the average data for all 18 sites. The baseline, 7 day, 30 day, 60 day and 90 day data represent data for all 18 sites. The 180 day data only represents data for 17 sites, while the 270 day data represent data for 15 sites, and the 360 day data only represent data for 10 sites. The 730 day data point is only based on the first site to be installed.

**Figure 3.** Average Yielding Compliance over time for all 18 sites that received the Rectangular-shaped Rapid Flashing (RRFB) LED Beacons

The results of this study indicate that the use of the *RRFB* increased motorist yielding rates significantly. These results showed clear safety benefits associated with the introduction of the pedestrian-activated device. One reason why this device is so effective may be related to the salience of the rapid flash sequence. Another reason may be related to the direct correlation between the pedestrians sign and the flashing device. The flashing device likely produces driver orientation to the pedestrian sign and making it stand out from the clutter.
